DEER LAKE DAM

(NDI ID NO. PA-00698,
DER ID NO. 64-202)

PHASE I INSPECTION REPORT
NATIONAL DAM INSPECTION PROGRAM

JANUARY 1981

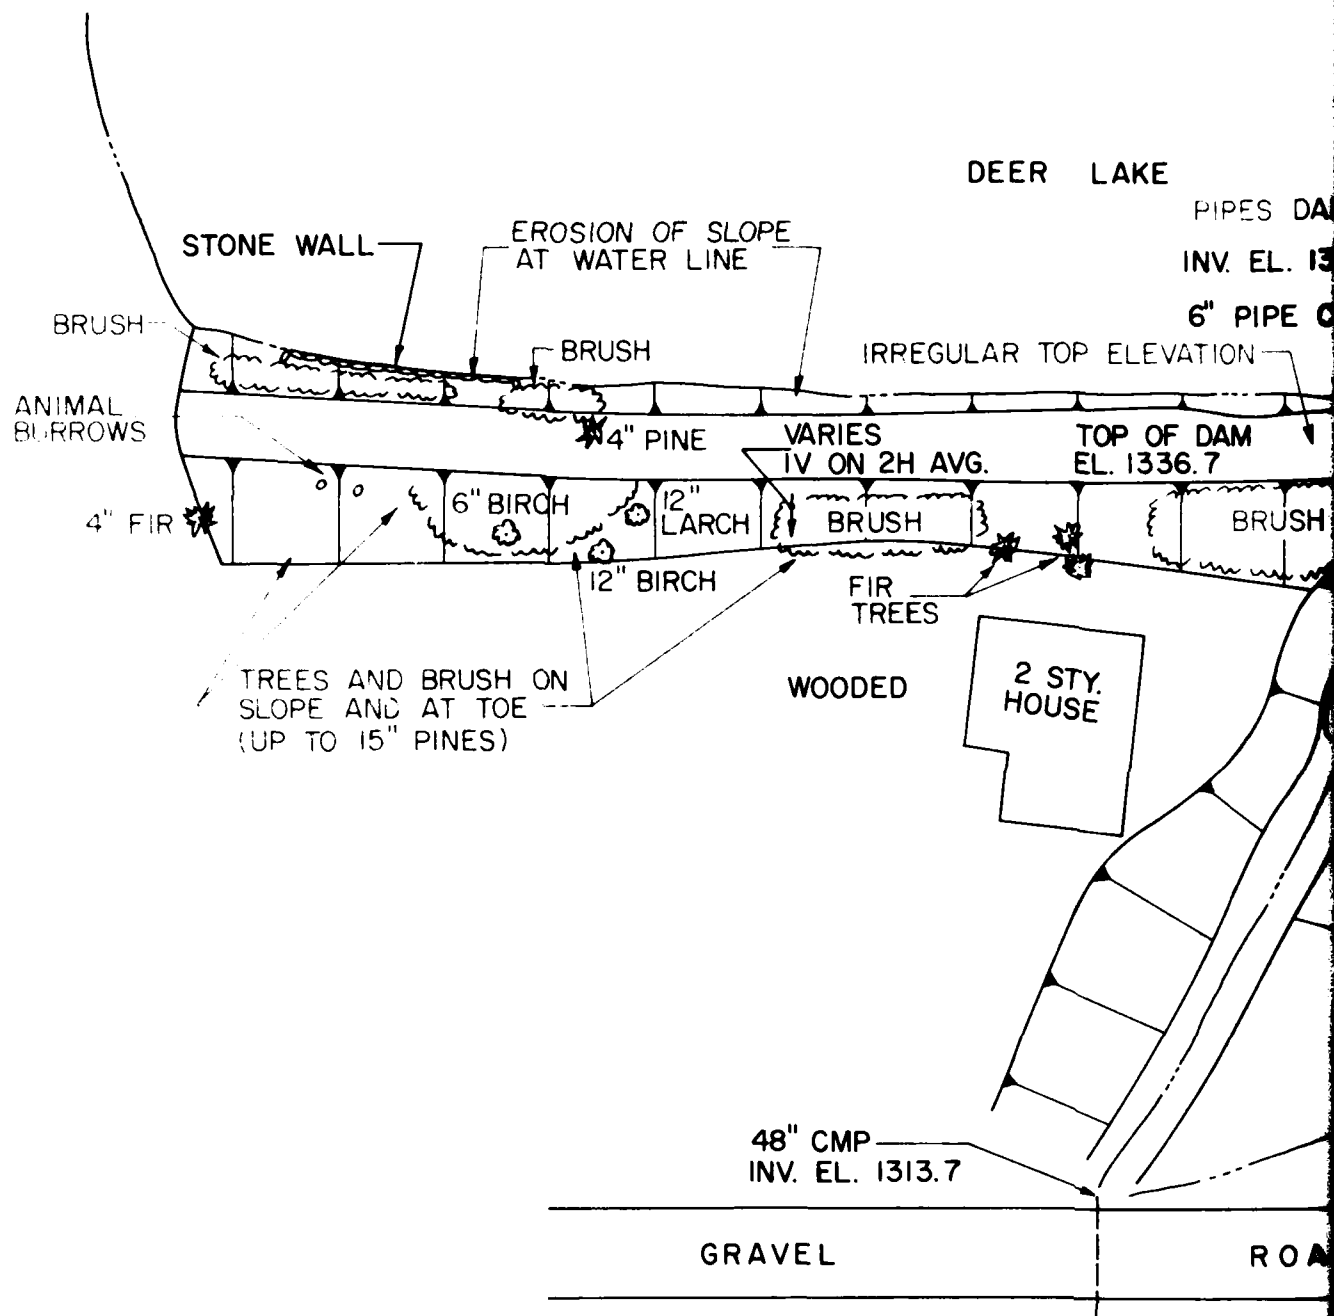
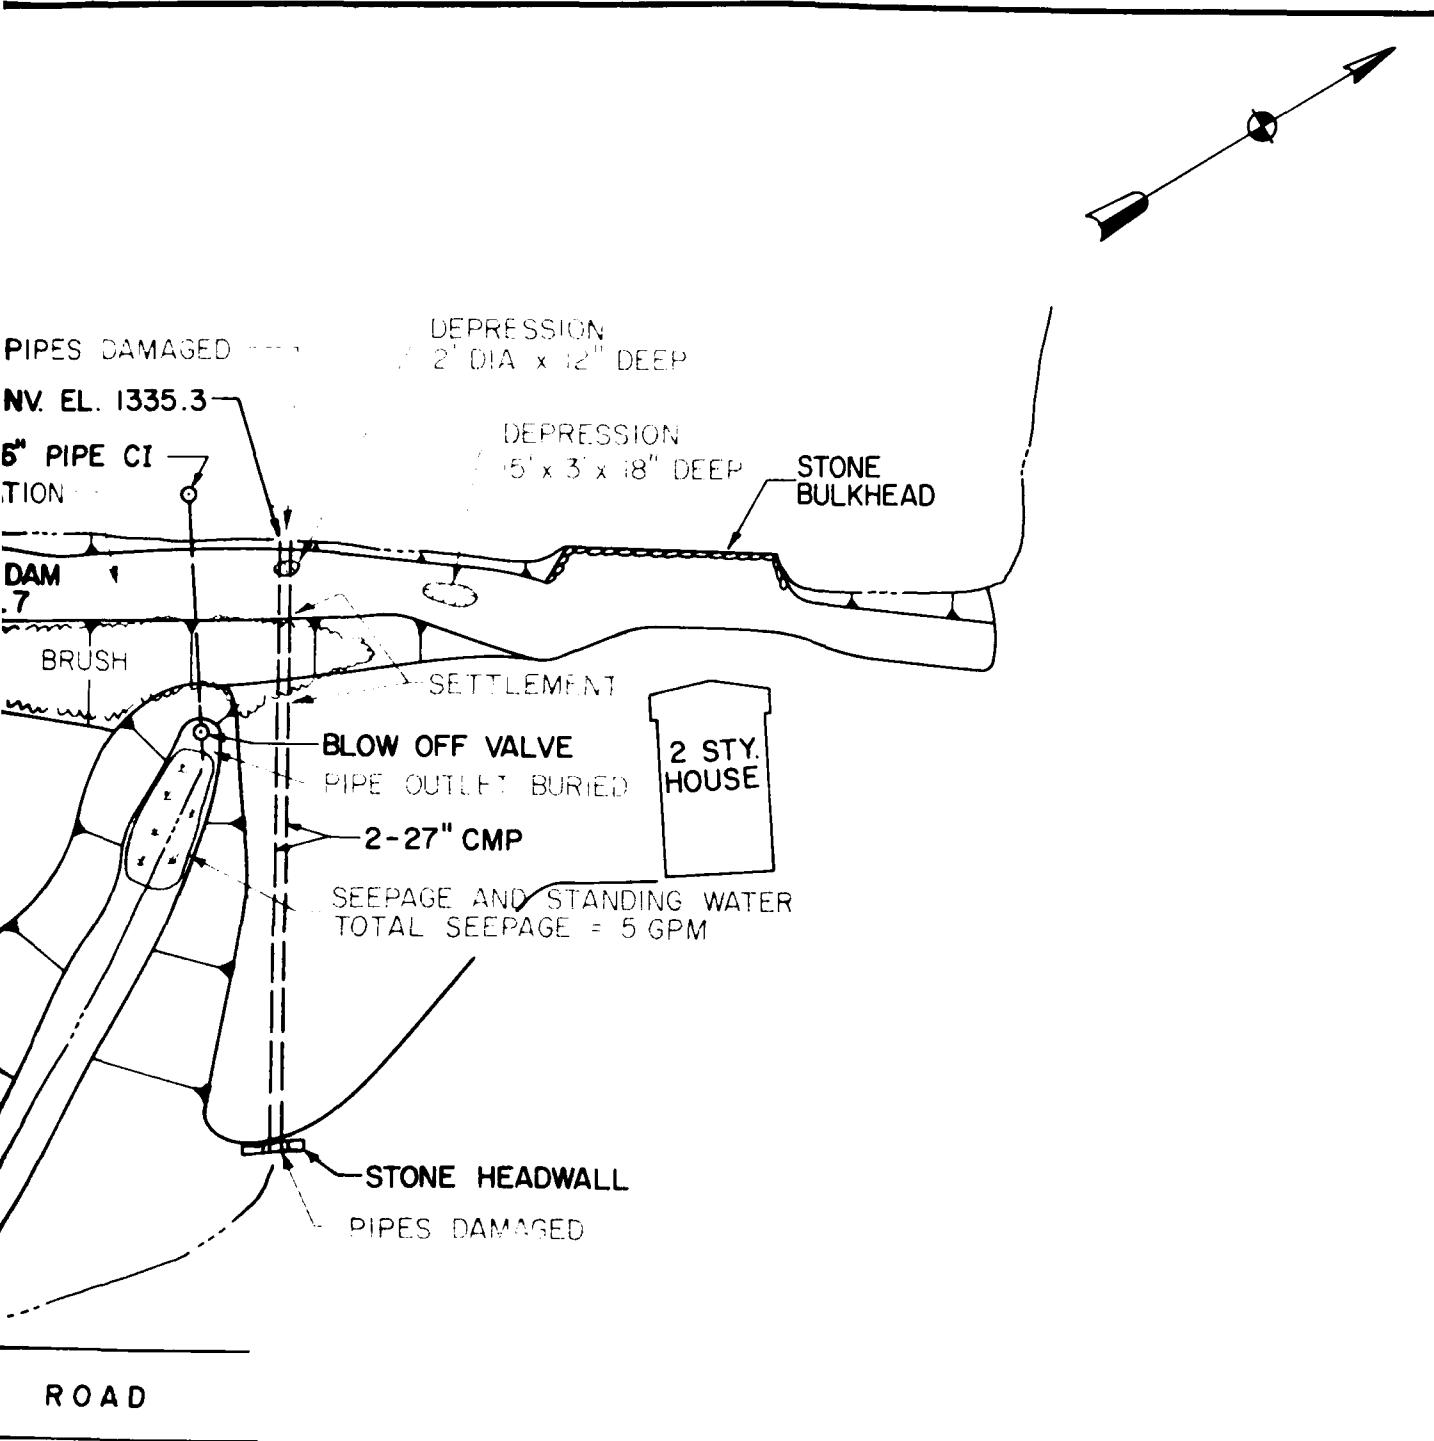
a. General. The overall appearance of the dam is fair. Some deficiencies were observed as noted below. A sketch of the dam with the locations of the deficiencies is presented on Exhibit B-1 in Appendix B. Survey information acquired for this Report is summarized in Appendices B and E. Datum for the survey was taken at the water surface, Elevation 1335.0, which is also the elevation of the 6-inch diameter cast iron pipe outlet.

DATE OF INSPECTION: 28 OCTOBER 1980
POOL ELEVATION: 1335.0 FEET
